# **Hayle Harbour**

## Maintenance Dredging Protocol Document

**Job no 022961** May 2010

Revision 03 Final

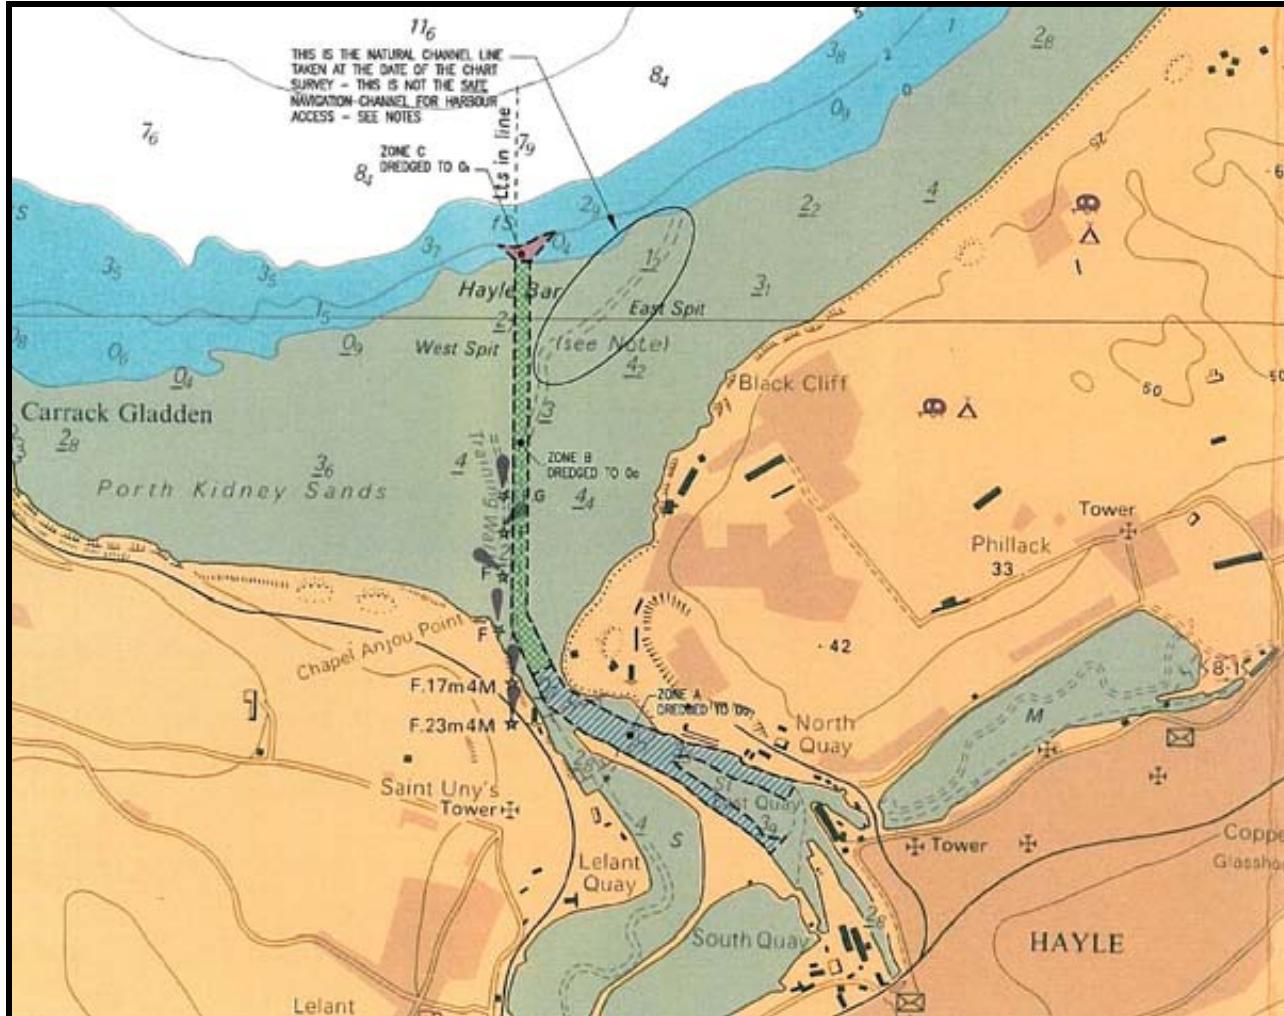
Figure 1: Locations of Maintenance Dredging

Shown in Figure 1 below is the area of maintenance dredging, as referred to in the Penwith District Council CPA Licence, which is due to be replaced by a Cornwall Council licence as the current licence has now expired.

The dredging area shown in Figure 1 is split into zones in order to assist instructions to the dredging contractors, the recording of dredging operations and the identification of better practices within the areas specified. The current proposed zones are:

Zone A – Inner Harbour – target to be dredged to 0.0m CD

Zone B – Approach Channel – target to be dredged to 0.0m CD

Zone C – Hayle Bar – target to be dredged to 0.5m CD

Following the completion of the initial dredging in 2009/10 it is currently anticipated that the weight of sand requiring dredging to achieve the target depths and channel widths indicated in Figure 1 will be approximately 400,000 tonnes and this can be broken down as indicated in Table 1 below:

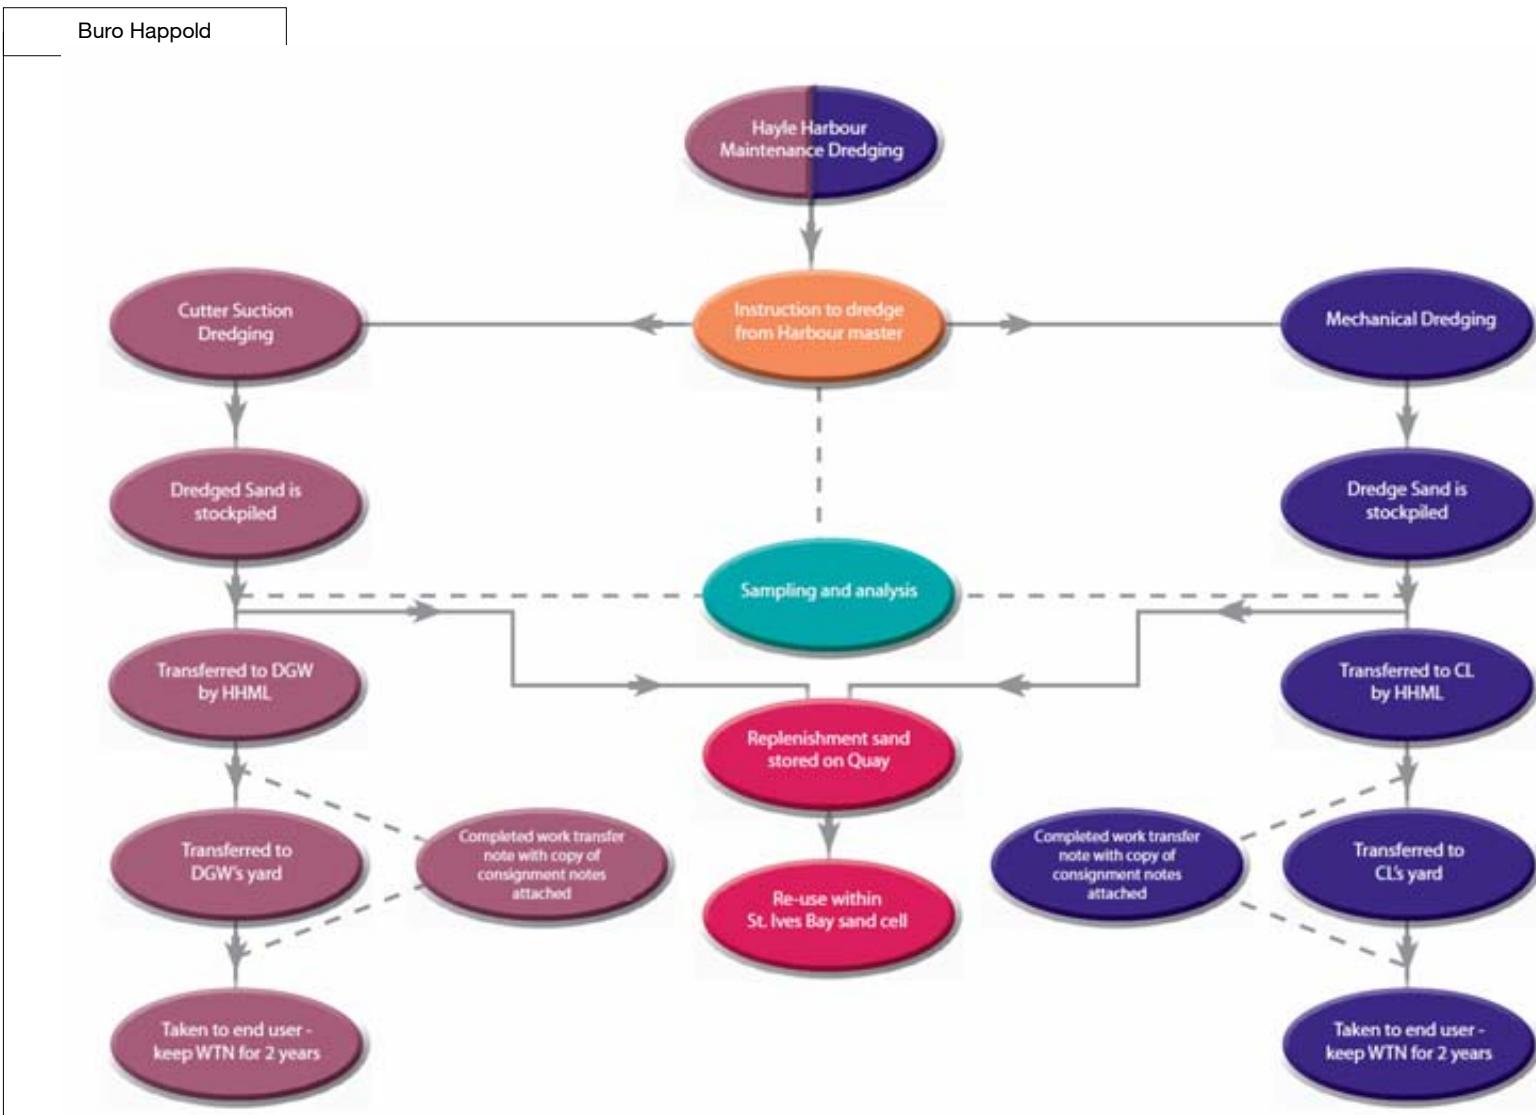
**Figure 2 – Waste Management Process**

The process for the waste management of the sand under the recently expire Penwith licence is as indicated in Figure 2 below.

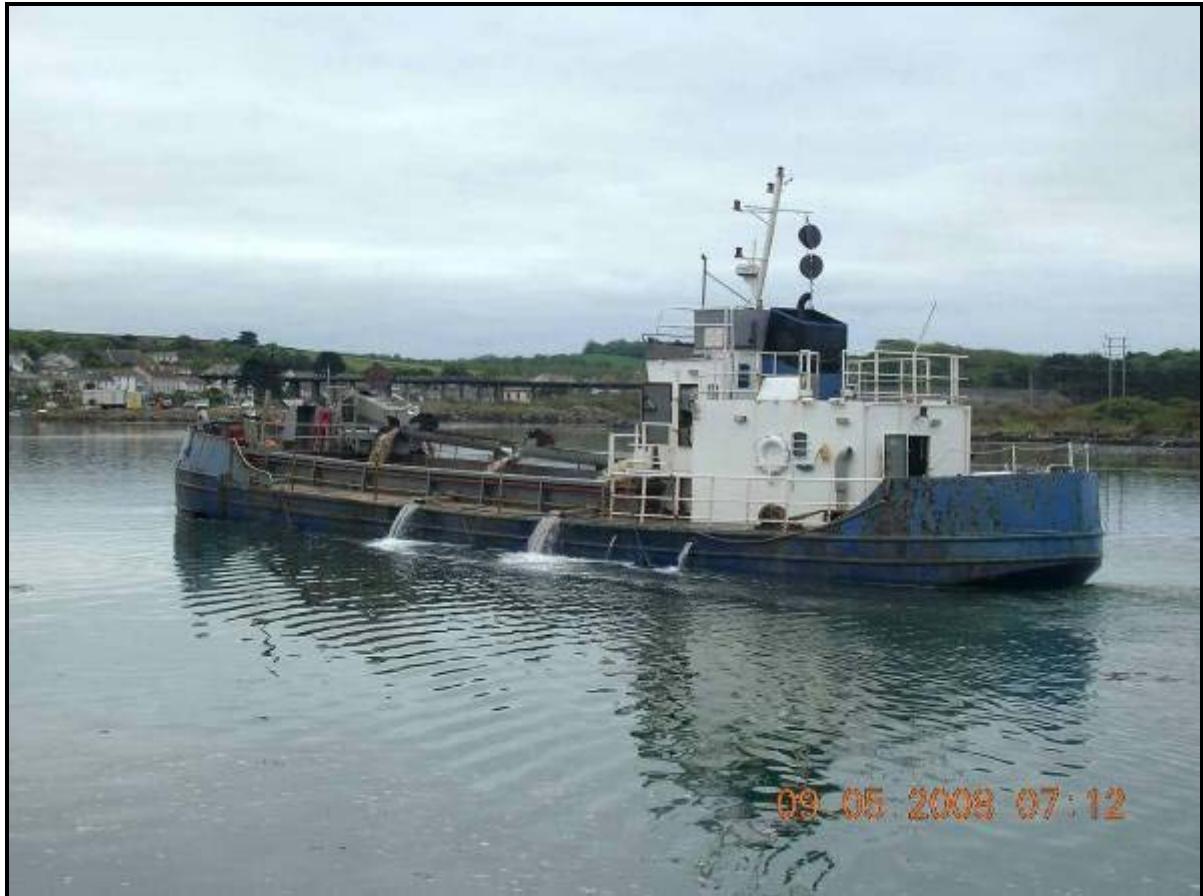
This method has become the method of choice despite the process being slow because of the vessel size restrictions. The current vessel, Tay Sand, is able to remove sand from specific areas and off load using an excavator to the quay-side for re-use. This vessel is not currently suitable for offloading at sea or using pumping techniques but could be modified or an alternative vessel identified that is of a similar size. It was previously used up until October 2001 after which the mechanical dredging option was employed.

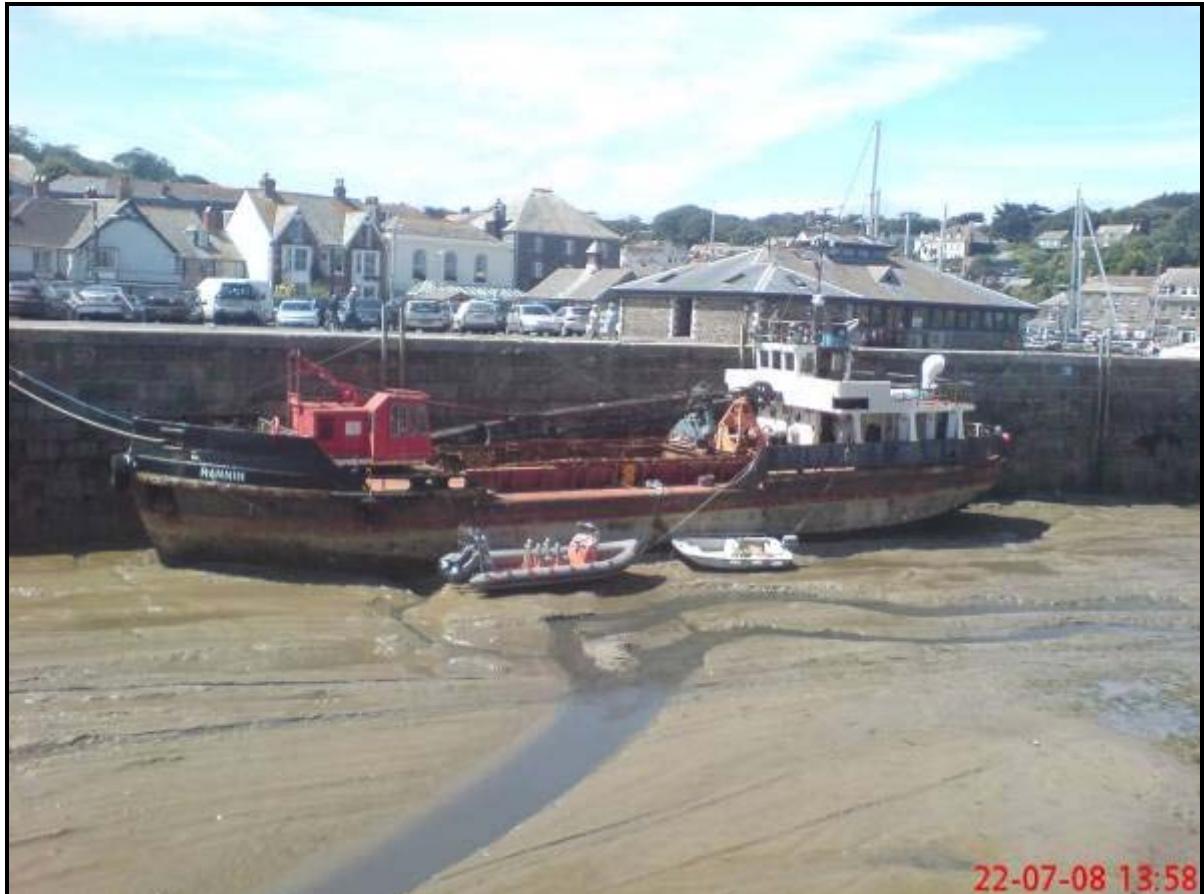
The MV Mannin is a grab dredger which is owned by the Padstow Harbour Commissioners, that was used for a period when the dredging was urgent. This dredger was able to load/unload using its own grab. It also has a split hopper which could allow sand to be discharged to the seabed.

However, this type of dredger causes holes to be created which fill with seaweed and other materials. This was found to be an issue when re-introducing the cutter suction dredger to the same areas. Dredging rates are similar to the cutter suction dredger.

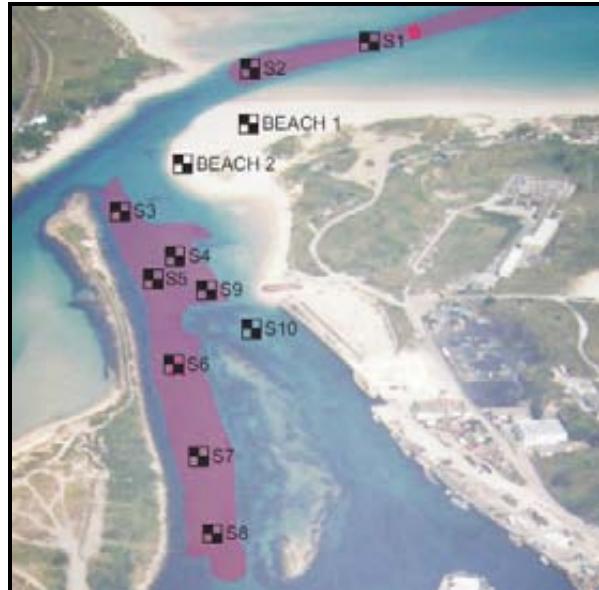
**Figure 3 – Benchmark Sample Locations**

The areas tested are as indicated in Figure 3 below.

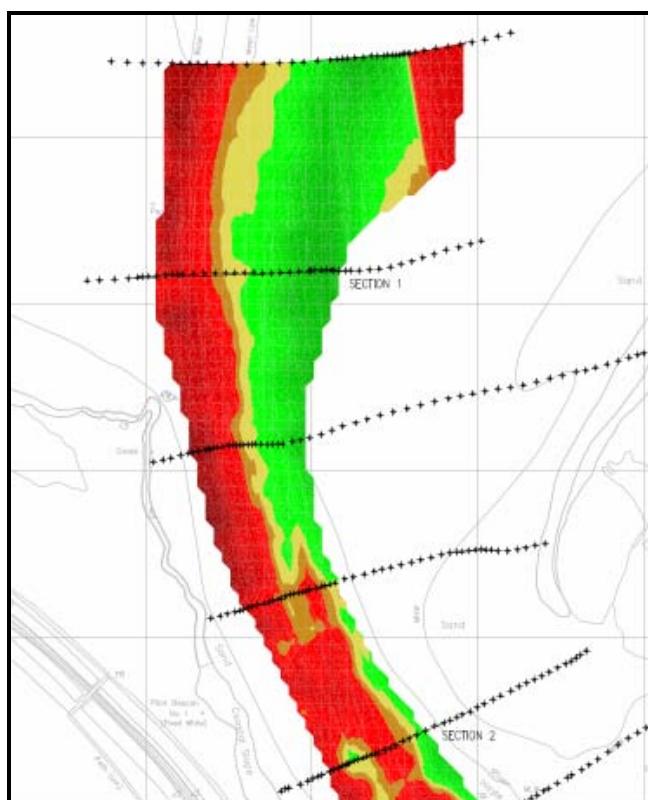
Using some historical levels it was possible to consider general areas of the dredging improvements in the first year of maintenance dredging.

This simply confirmed what could be seen on site with the channel moving back to the west (red) and the beach levels recovering where the channel had previously meandered across to the east (green).

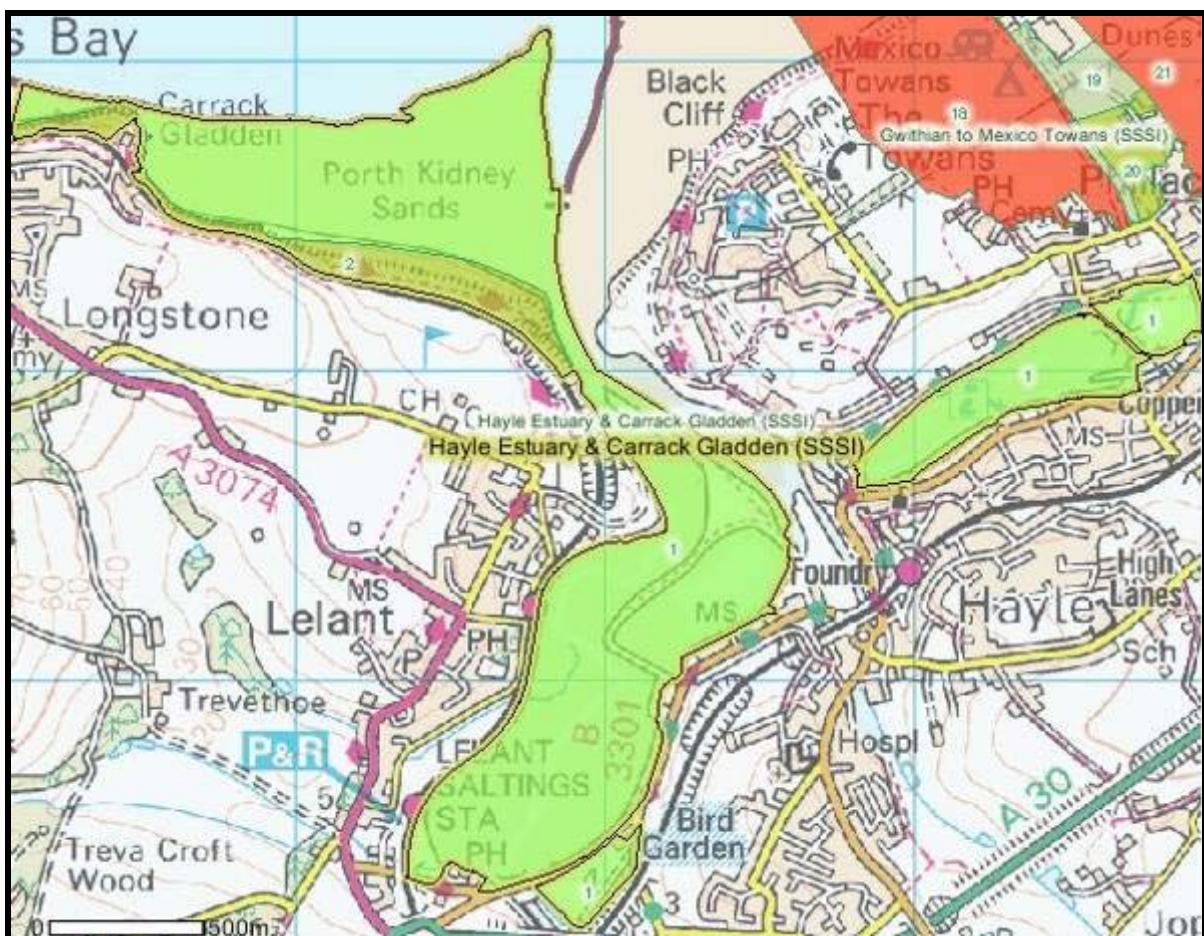
**Figure 4 – SSSI Boundaries as Defined on the Natural England Website**

The harbour is within the Hayle Estuary and Carrack Gladden SSSI as shown in Figure 4 below.

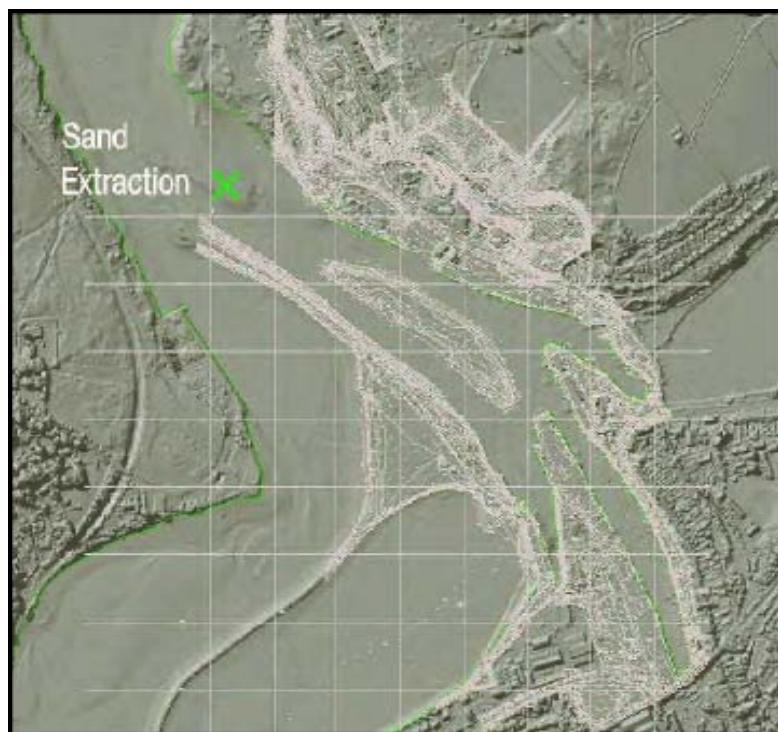
LIDAR Map Location of Past Dredging

Mechanical dredging is known to have been undertaken at Hayle Harbour from a location to the North West of the North Quay since March 1999, shown in the map below. During 2003 and 2004 an average of 1,800 tonnes of sand per month were being extracted and this is detailed in 10.2 below. Based on an approximate density of 1.8 tonnes per cubic metre, this equates to an approximate extraction rate of 1000m<sup>3</sup> per month.

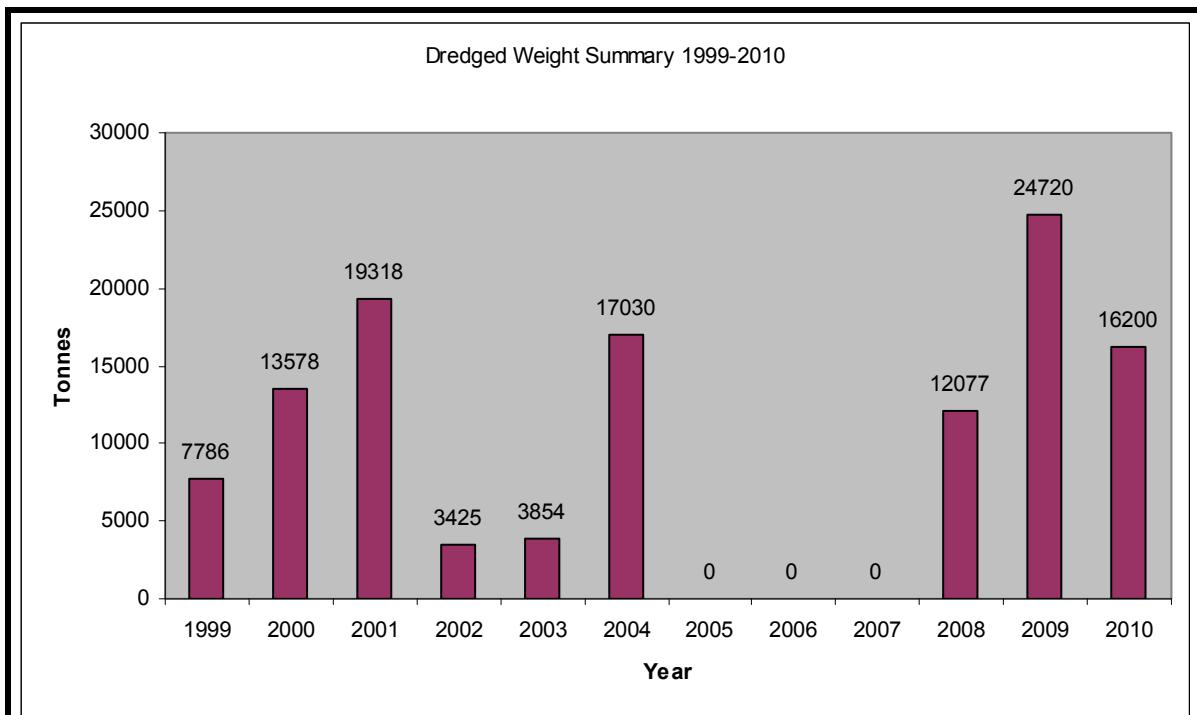
Hence, using historical and recent dredging records, the following bar chart shows the weight of sand removed from Hayle Harbour since 1999, based upon available records.

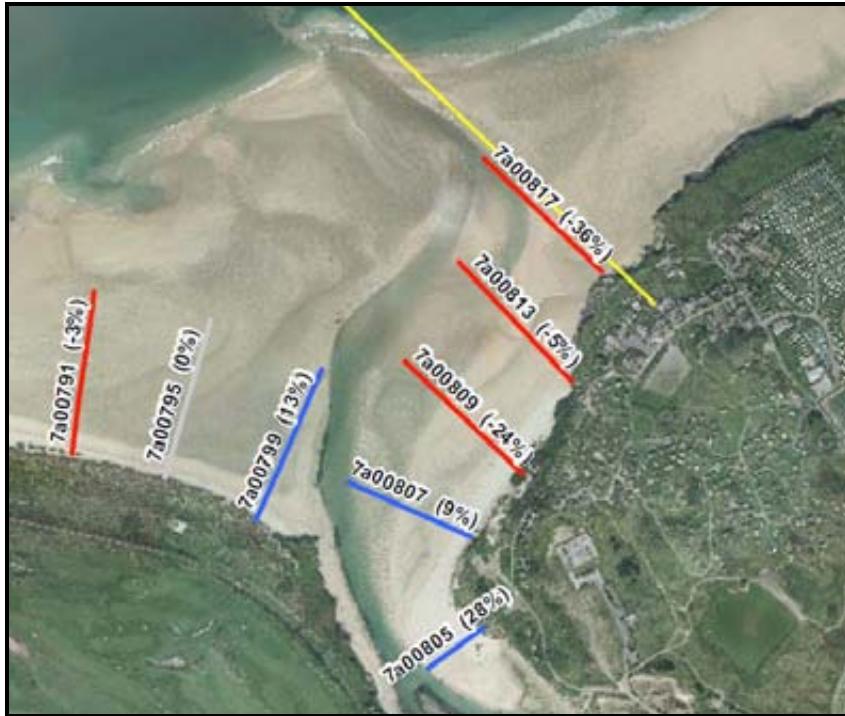
Coastal monitoring that was started in 2007 by the Plymouth Coastal Observatory has shown some accretion and erosion of beach levels over a two year period, as indicated in the following extract.

This shows accretion in the harbour channel and doesn't extend as far as Lelant where RSPB records suggest further accretion has occurred. As this survey information is added to then a more full understanding of the changes in beach levels will be possible as the above is a snap shot in time of a very dynamic beach. The impact of the maintenance dredging is considered to be minimal given that historically the sand was dredged and a much deeper channel was maintained with no known impact on the beach levels.

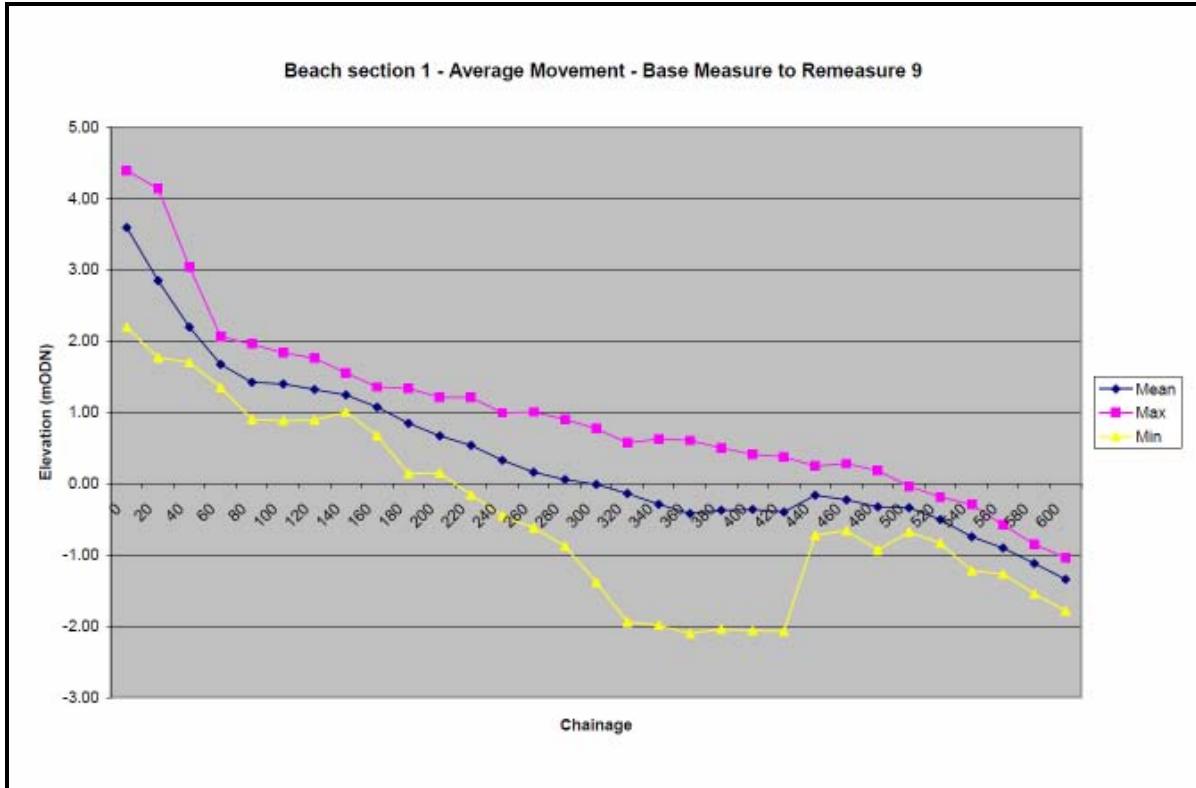
The work for "Wave Hub" also had beach level monitoring undertaken and this showed a fluctuation in level over a similar period as the current coastal modelling. The figure below shows the impact of the channel moving in an eastwards direction following the ending of the dredging and the channel moving along the beach, as indicated in the aerials in 12.1 of this document.

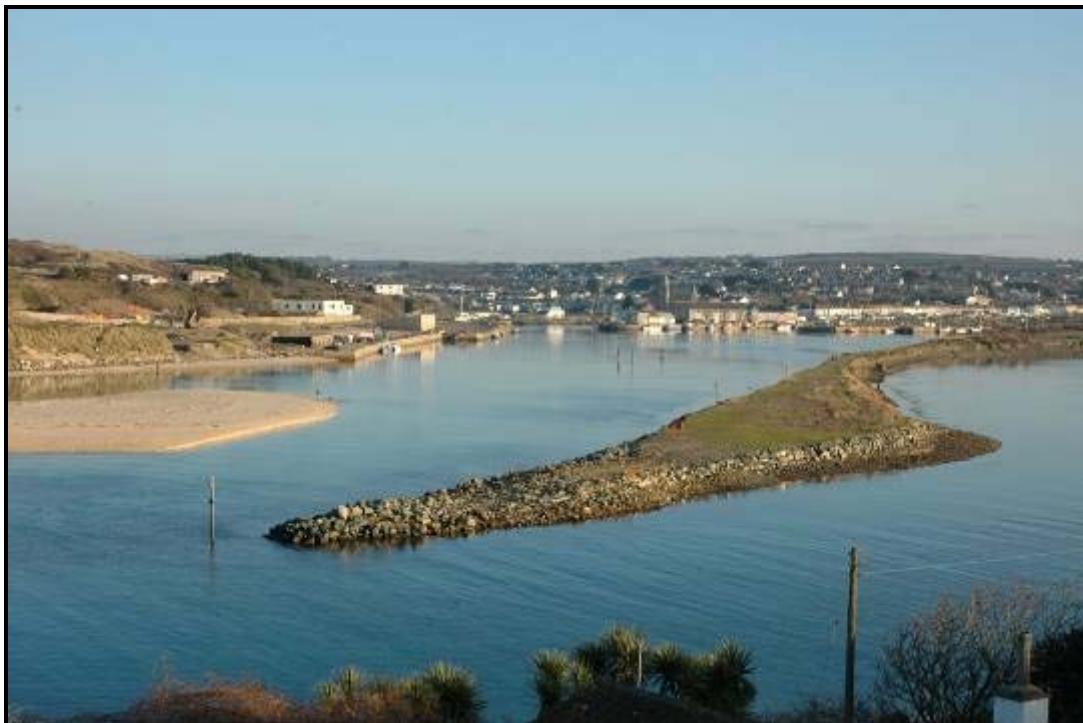
The middle weir separates the harbour from Lelant and channels any flow from the Copperhouse and Carnsew Pools out through the channel. Similarly it directs flows out from Lelant in a direction that helps to keep the harbour entrance channel clear.

The Middle Weir also provides protection to Lelant from incoming waves during severe NW storms. During these storms significant amounts of sand are known to be moved and this can be readily observed within the Lelant SSSI where sand has built up.

Raising of the Middle Weir could assist in reducing the amount of sand taken into Lelant during severe storms by preventing so many waves, that carry the sand, from overtopping middle weir and entering this part of the harbour. Instead the sand would be deposited in the harbour channel where water flow would remove it. This would need to be undertaken using rock obtained locally and to raise the area by approximately 1m would be expected to cost in the region of £40k subject to access constraints.

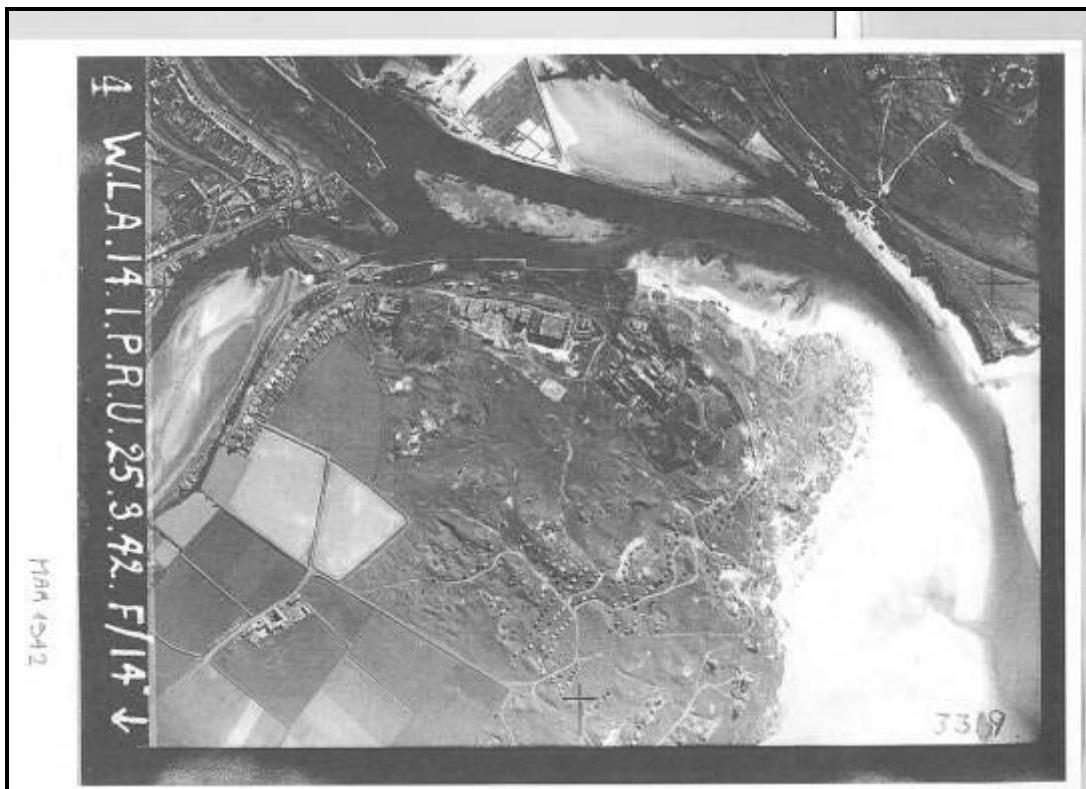
1942

However, the impact of no dredging is very clear as indicated in the 2009 aerial image, which followed a period of approximately five years without dredging.

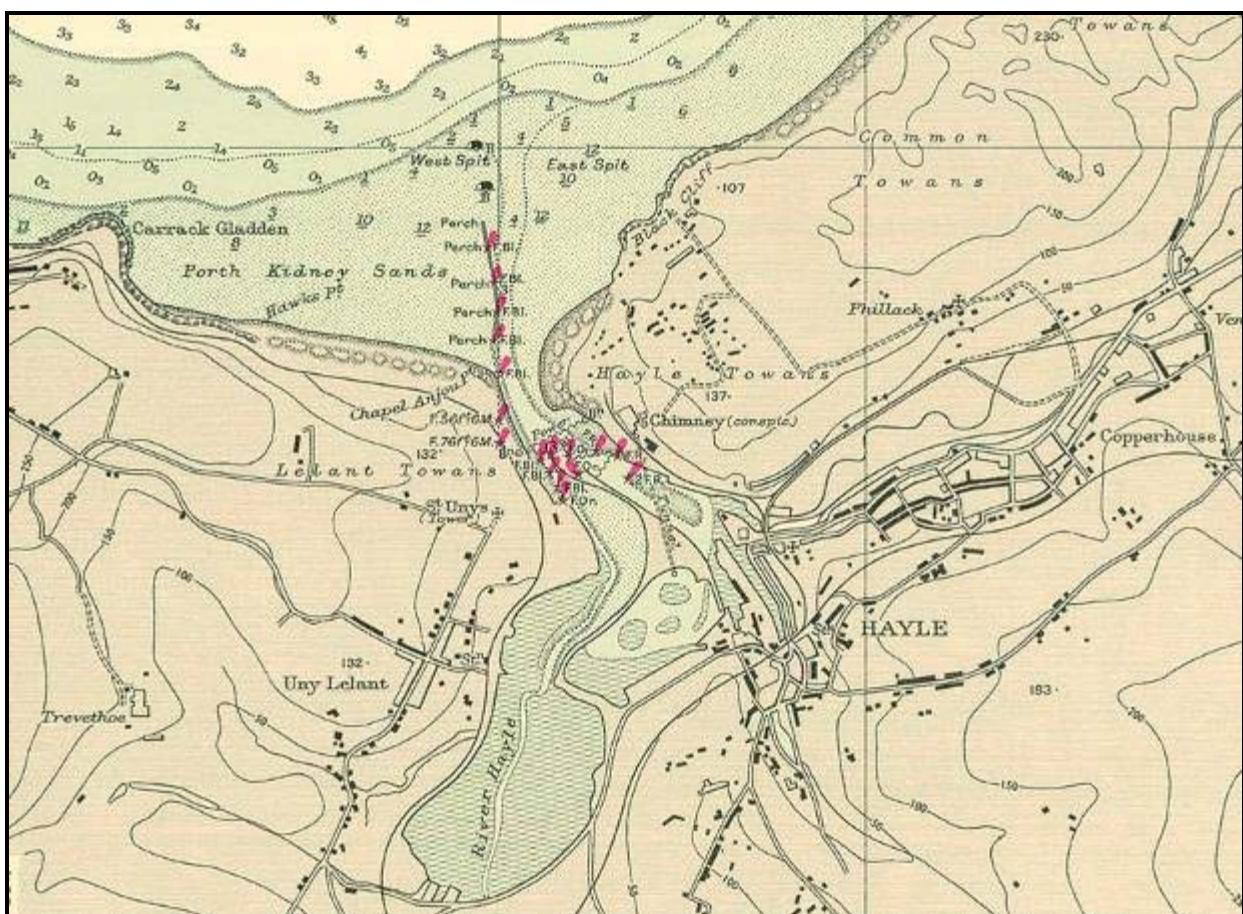
### 1954 Chart (Depths in Feet)

The historical navigation chart revisions for Chart No. 1168 have been purchased from the UK Hydrographic Office and are Copyright protected. For the purpose of this Protocol, extracts from the charts for 1954, 1972 and 1986 are provided below.

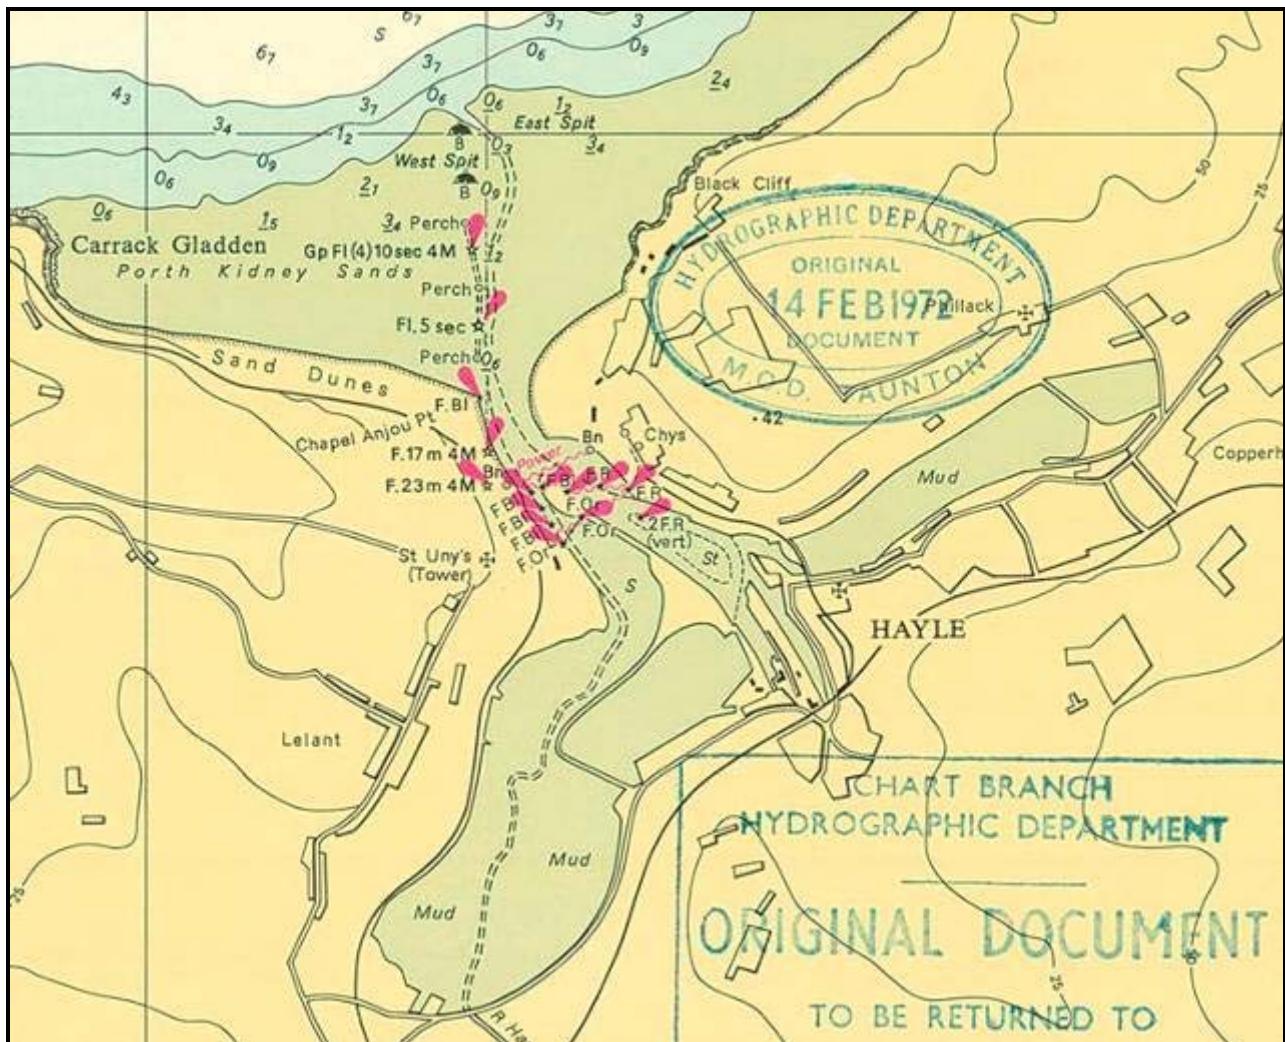
1972 Chart (Depths in Metres)

The 1972 Chart appears to be the most relevant to the target depths being considered for the proposed maintenance dredging and this correlates well with the time that the port was in frequent use and a channel provided for vessels. By 1986 the commercial activity in the harbour had been lost and the site was under various ownerships prior to the Hayle Harbour Harbour Act coming into force.

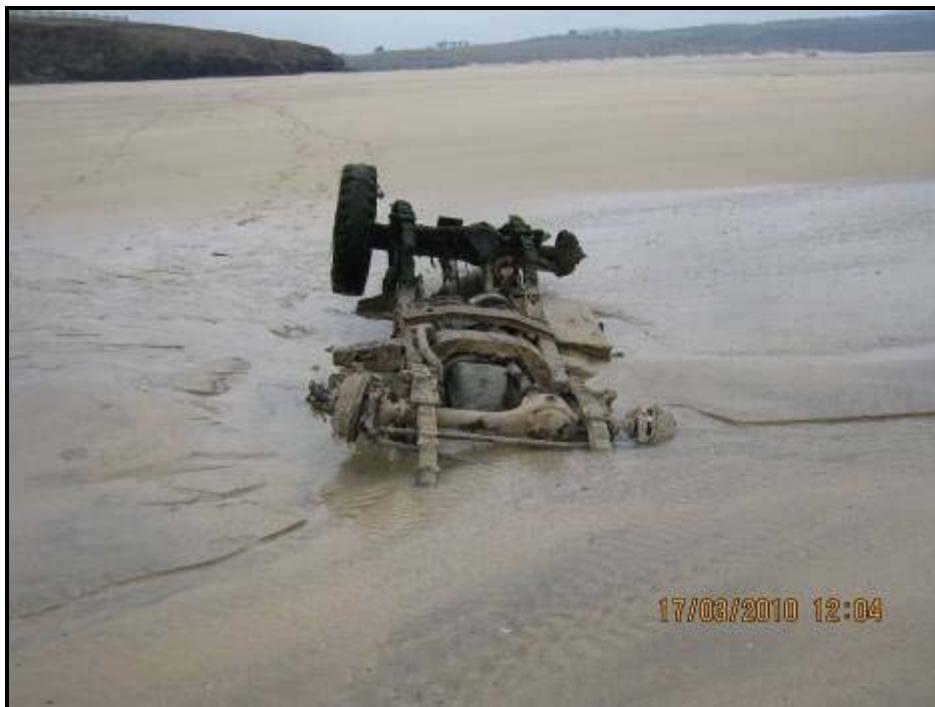
The photo below is of the Land Rover lost to the sea some 15 years ago, which makes an annual appearance when beach levels drop during the winter and which is then buried again as sand is deposited during the summer. It should be noted however that the position of this vehicle continues to move in a westerly direction, acting as an indicator of longshore drift, and at some point it will fall into the navigation area when the harbour company will have to remove it, despite other organisations not having to.
